SAFETY OF WIND SYSTEMS

© M. Ragheb
2/26/2011

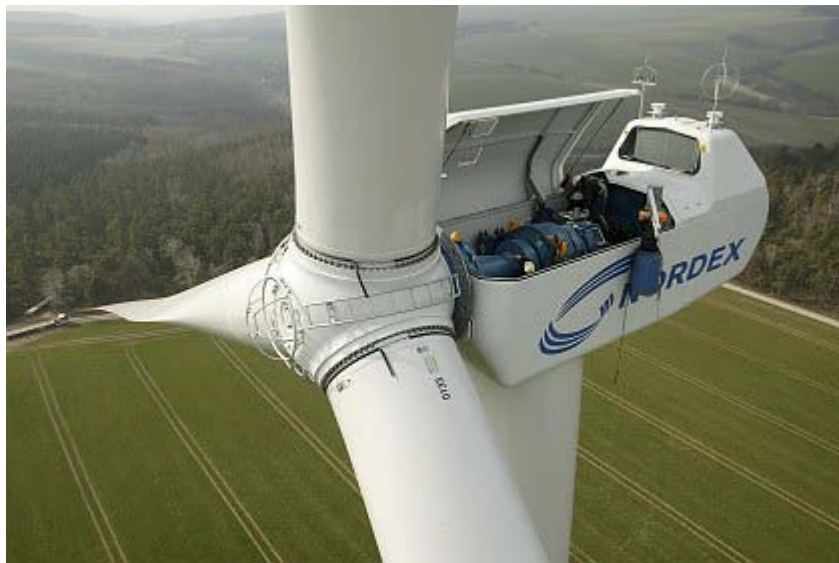
Figure 1. Maintenance at wind turbines nacelles involves work at about 100 meters height. Source: Getty, Nordex.

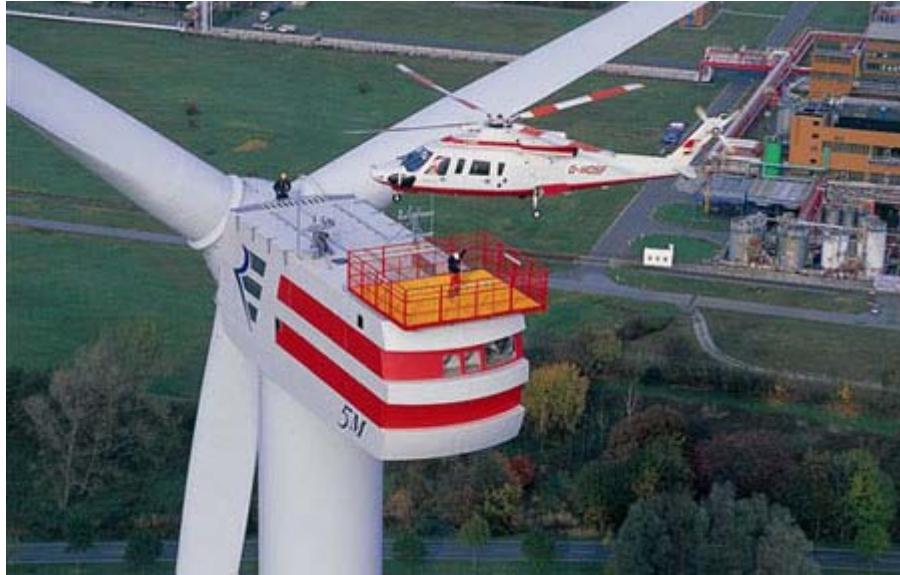
Figure 2. Maintenance access of a wind turbine's nacelle through the use of a helicopter.

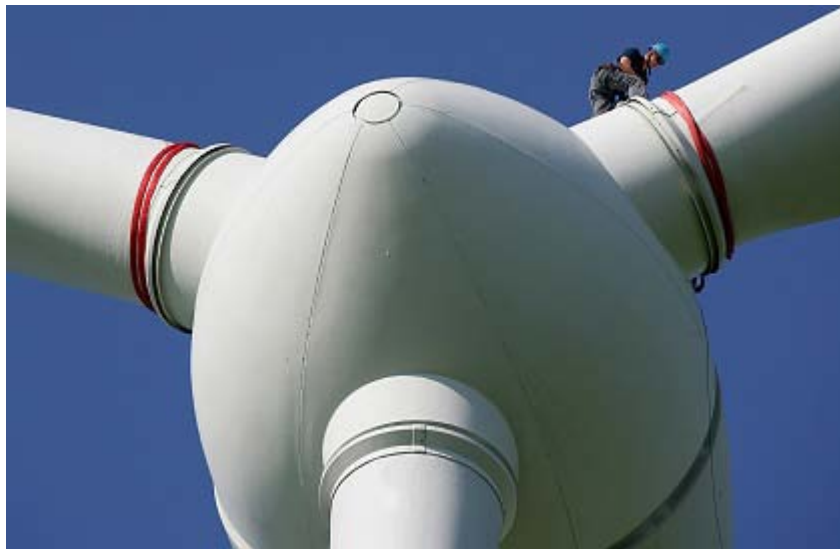
Figure 3. Assembly of wind turbine components entails work at great heights and use of safety harness equipment.

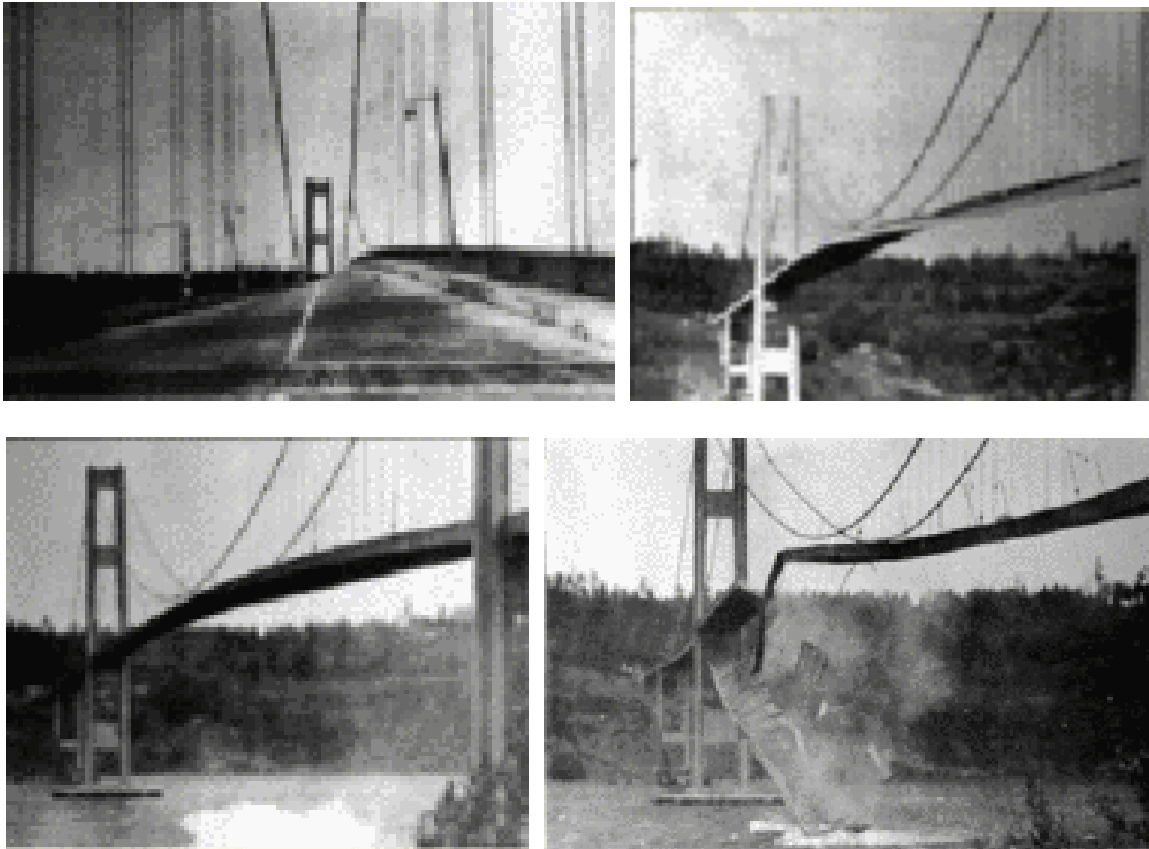
Figure 8. Torsional flutter aeroelasticity failure of the Tacoma Narrows Bridge, State of Washington, USA, 1940.

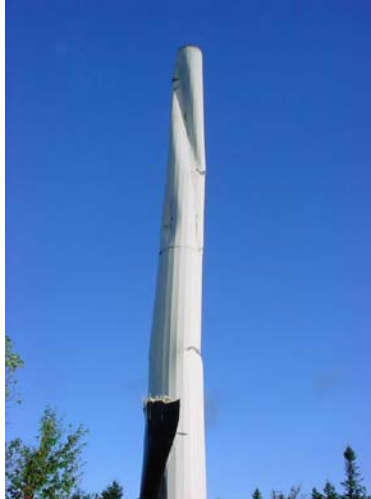
Figure 9. Turbine collapse in high wind conditions at the Searsburg, Vermont wind facility, September 15, 2008.

Turbine collapse occurred in high wind conditions at the Searsburg, Vermont wind facility on September 15, 2008. One of the rotor blades hit the base causing the tower to buckle and the nacelle and rotor assembly to crash to the ground.

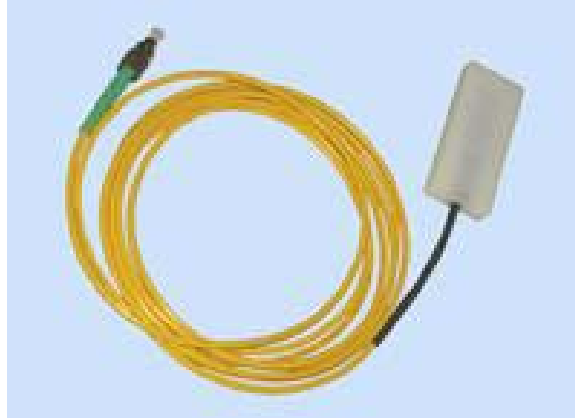
Figure 10. Fiber optics vibration sensor. Source: VFT VibroFibre.

Wind turbines are equipped with a vibration sensor located inside their structural tower. It consists of a ball bearing sitting on a ring. The ball bearing is connected to a disconnect switch through a chain that would turn the turbine off in case of excessive vibration. Fiber optics vibration sensors are used within the electrical components enclosures.

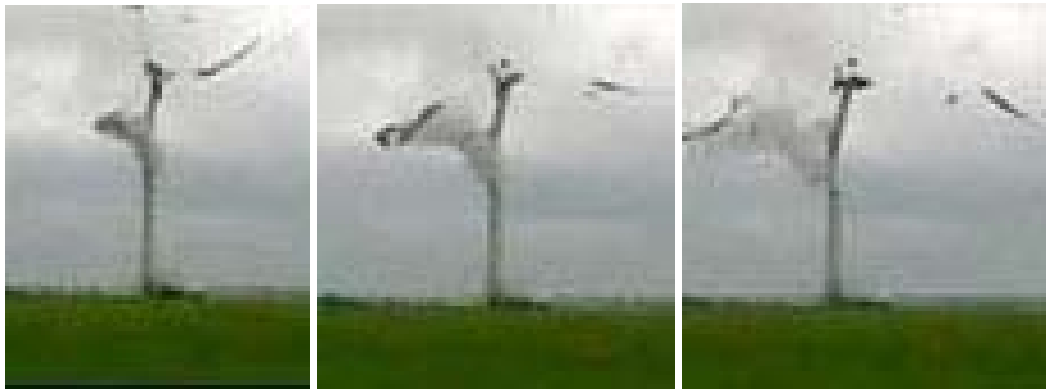
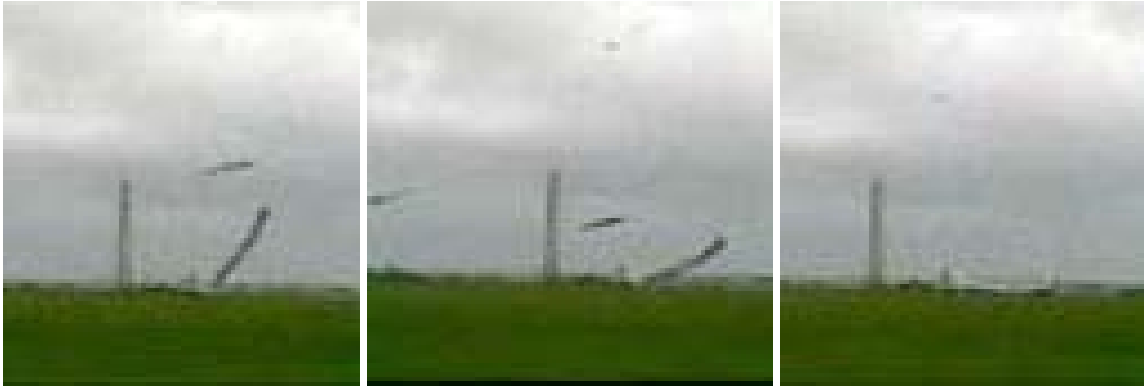
Figure 11. Runaway turbine disintegration clip sequence from video caused by failure of brake system, 2008. Notice how an initiating event of a single blade failure evolved into a failure sequence where the unbalanced nacelle and hub caused another failed blade to hit the structural tower, slicing it and causing it to collapse while the disintegrated rotor blades were ejected away. Source: UTube.

A possible initiating event for overspeed failure is a generator overheating or being disconnected from the grid. The accident sequence that follows involves the inability of the generator to brake the rotation of the rotor. The rotor would start accelerating in its rotation within seconds of the initiating event.

To prevent such an accident sequence an overspeed protection system is essential. Safety regulations specify that such a system must have two independent fail-safe brake mechanisms to stop the turbine.

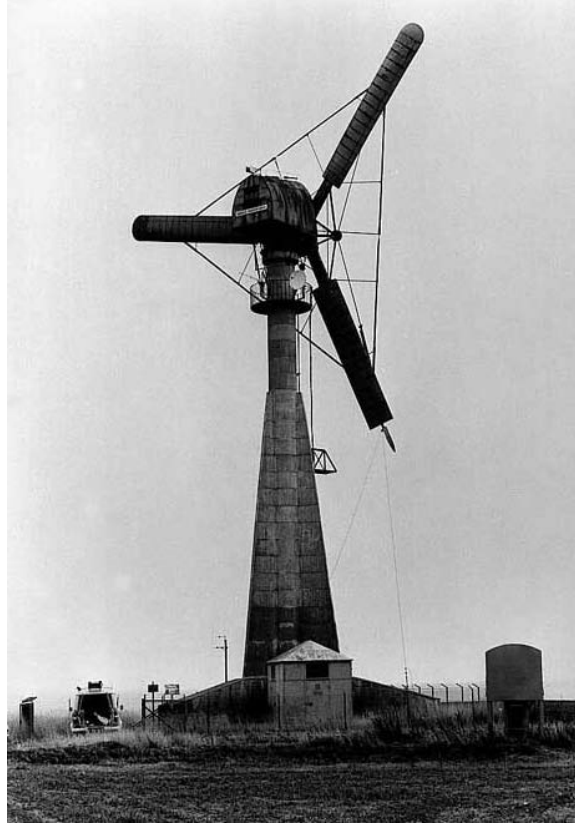
Figure 12. Emergency rotor tip brakes for the Gedser stall controlled wind turbine.
Source: Danish Wind Turbine Manufacturers Association.

Aerodynamic braking is the primary braking system for most wind turbines. It involves turning the blades about 90 degrees around their longitudinal axis in the case of a pitch controlled turbine or an active stall controlled turbine. In the case of a stall controlled turbine, the rotor tips are rotated 90 degrees.

The Gedser wind turbine design was equipped with emergency rotor tip brakes.

To make them fail-safe and operable in the case of electrical power failure, those devices are designed to be spring loaded and are automatically activated if the hydraulic system in the wind turbine loses its pressure. Once the hazardous situation is over, the hydraulic system would restore the blades tips or the whole blades to their original operational state.

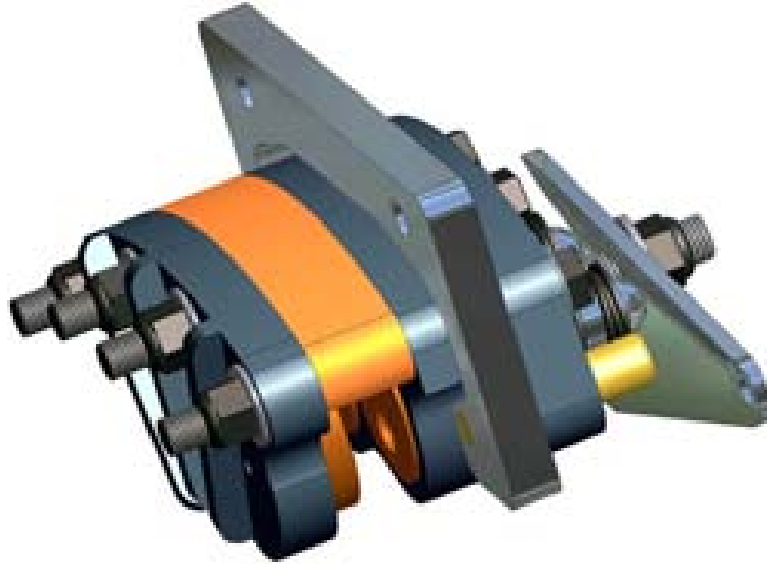
Figure 13. Wind turbine mechanical caliper disc brake. Source: WC Branham.

For reliability, a mechanical brake supplements the aerodynamic braking system in wind turbines. It also doubles as a parking brake when a stall controlled turbine is stopped. Its design draws on automobile brakes designs, but on a larger size scale.

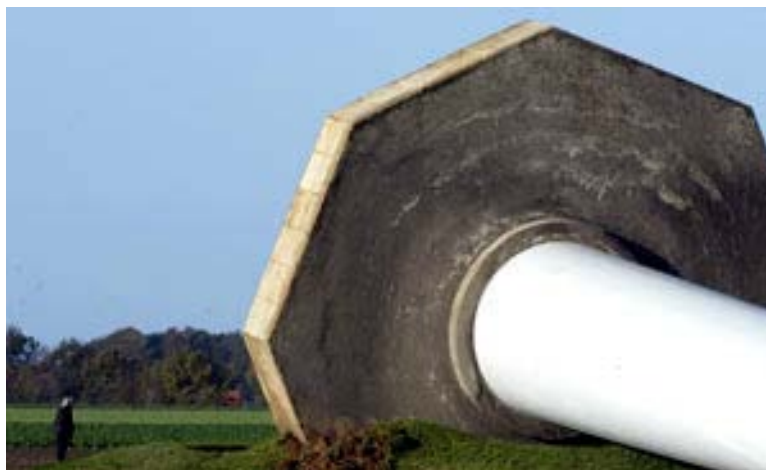
Figure 15. A 70-meter or 230-foot high tower collapsed in inclement weather at Goldenstedt, Germany, on October 28, 2002.

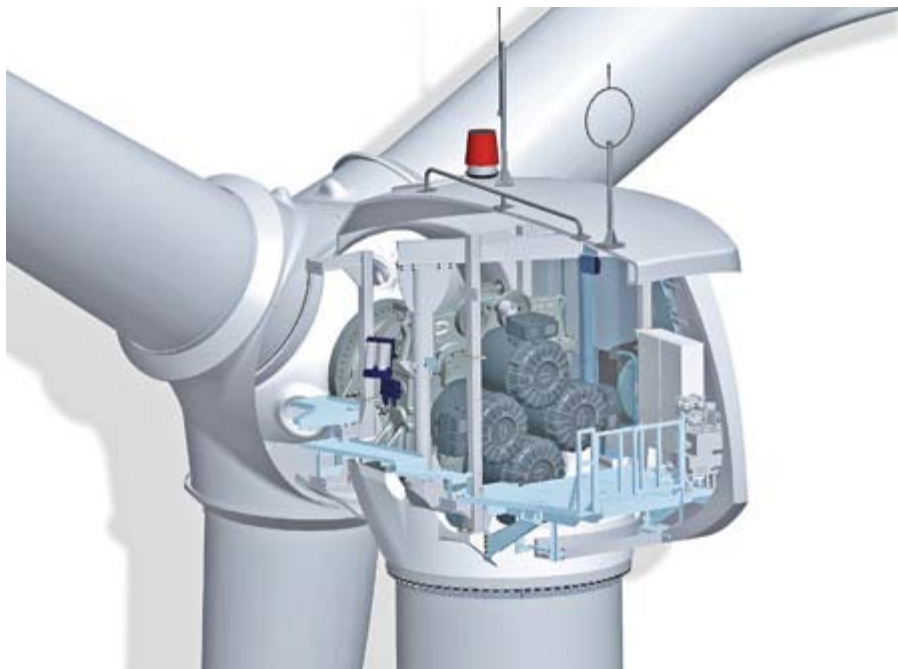
Figure 25. Torque splitting between four electrical generators operated in parallel. The turbine can continue operation with one generator out of service. Source: Clipper Wind Power Inc.

The turbines use a unique approach in their gearboxes to cope with the large torque generated by the turbine blades that are longer than the wing of a Boeing 747 airplane on the gear box. The drive train of the wind turbine uses torque splitting and feed it into four turbo generators operating in parallel. An advantage is that the turbine can continue operation with one generator out of service and waiting for repair.

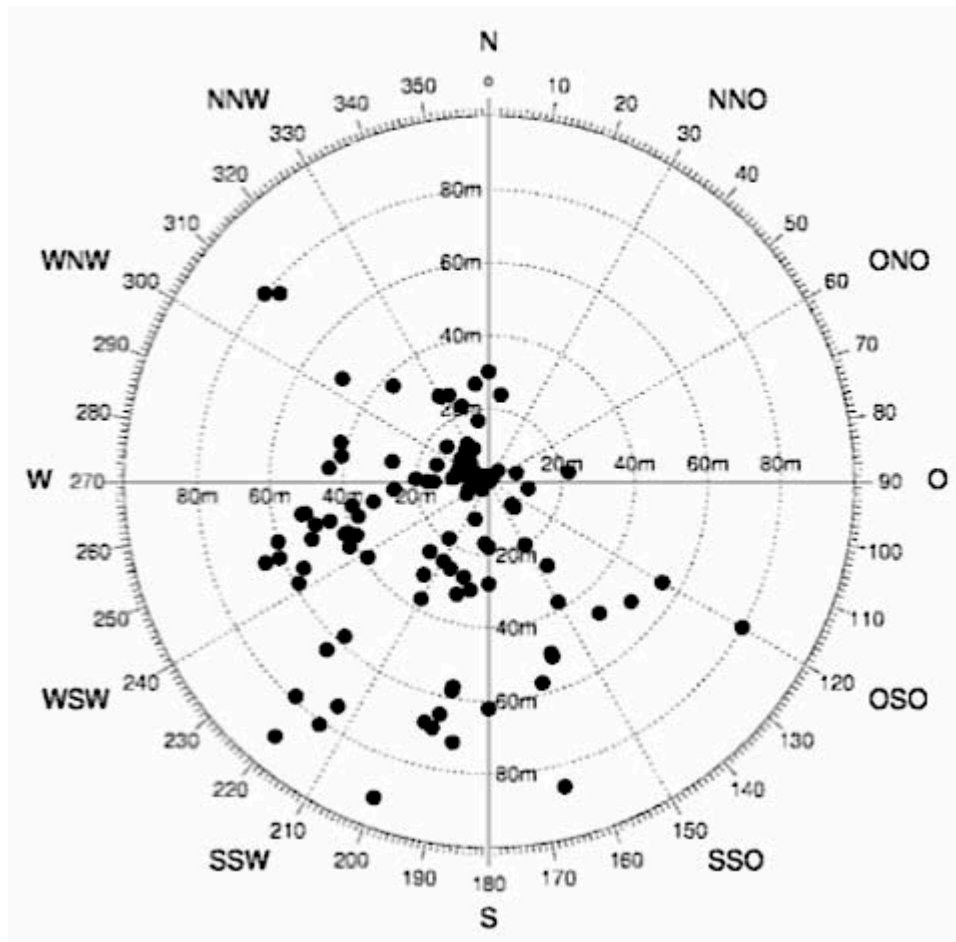
Figure 28. Frequency of an ice throw study in the Swiss Alps. Ice throws depend on the prevailing wind conditions and can reach a distance of 100 meters from the base of the wind turbine.

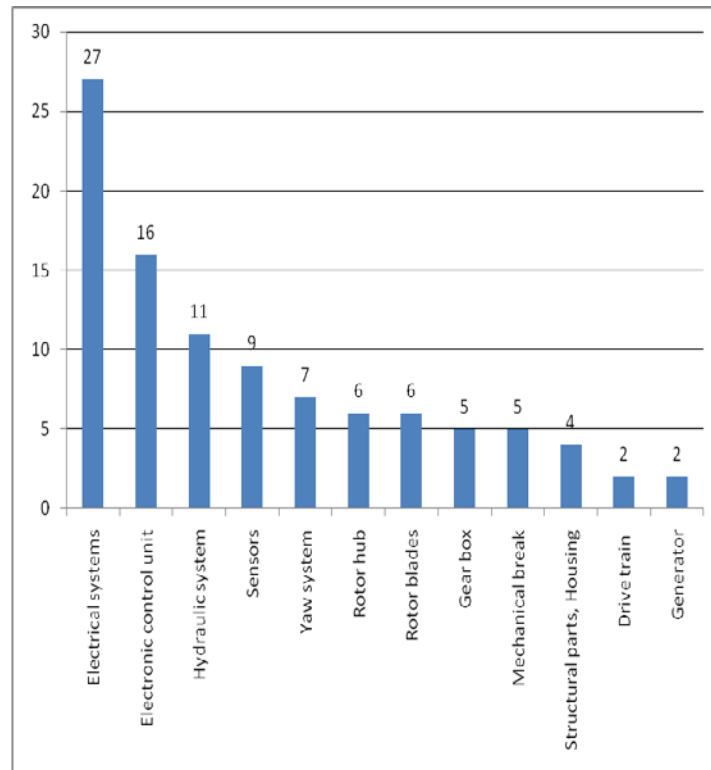
Figure 30. Percentage of needed repairs and maintenance on utility scale wind turbines. Data: AWEA.

Most of the repairs in occur in the electrical and electronic controls and the sensors units. The mechanical breakdowns are smaller in incidence but have more serious effects affecting the downtime of turbines.
